GRAND LAKE DAM  
ME 00180

PENOBSCOT RIVER BASIN  
GRAND LAKE MATAGAMON

PHASE 1 INSPECTION REPORT  
NATIONAL DAM INSPECTION PROGRAM

SUBJECT: Grand Lake Dam

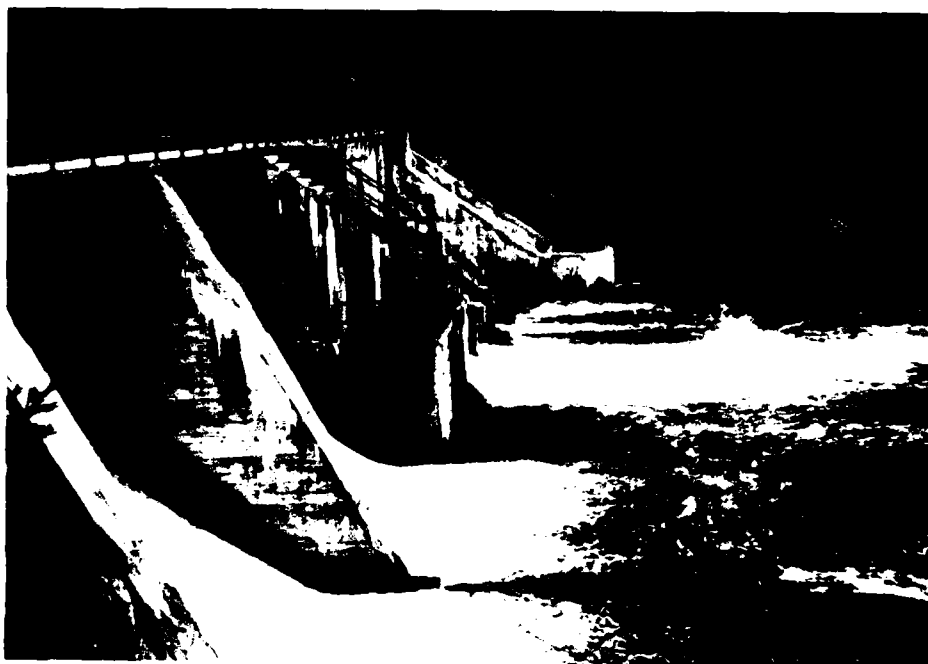
Fig. 1 Downstream  
view of dam from  
right bank. Note  
fish ladder at left  
embankment
